November 10th 2017

# Electrokinetic remediation of soil and groundwater

BRIEF SUMMARY

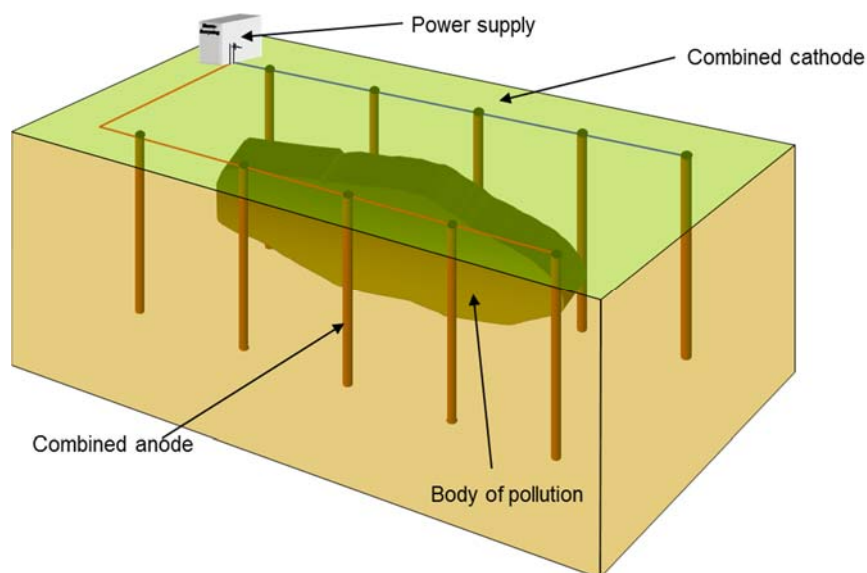
Figure 1: Basic EK-setup with distributed series connected electrodes typically used at sites up to 10 x 45 m.

A basic electrokinetic remedial system consists of a number of electrodes surrounding the soil contamination in question, a special power supply, and connecting cables.

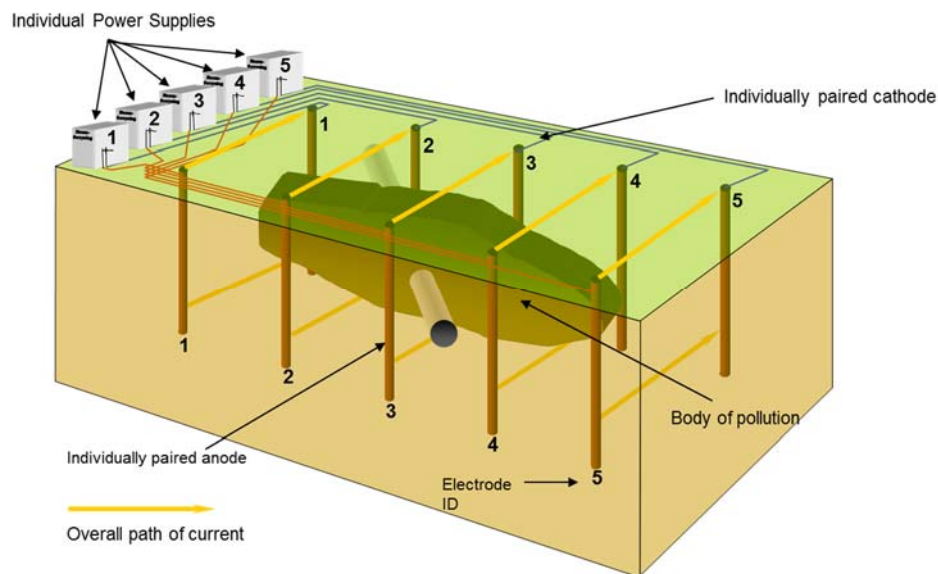
Figure 2: EK-setup with individually powered pairs of electrodes typically used at sites large areas and/or obstacles in the ground.

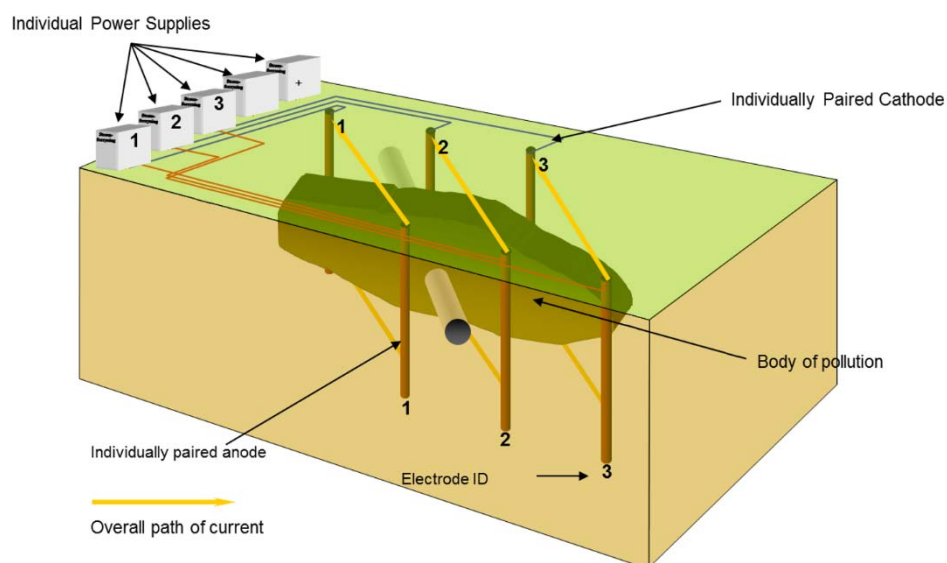
Figure 3: EK-setup modified from Figure 2 with only three but individually powered pairs of electrodes. The path of current is modified due to an obstacle in the ground.

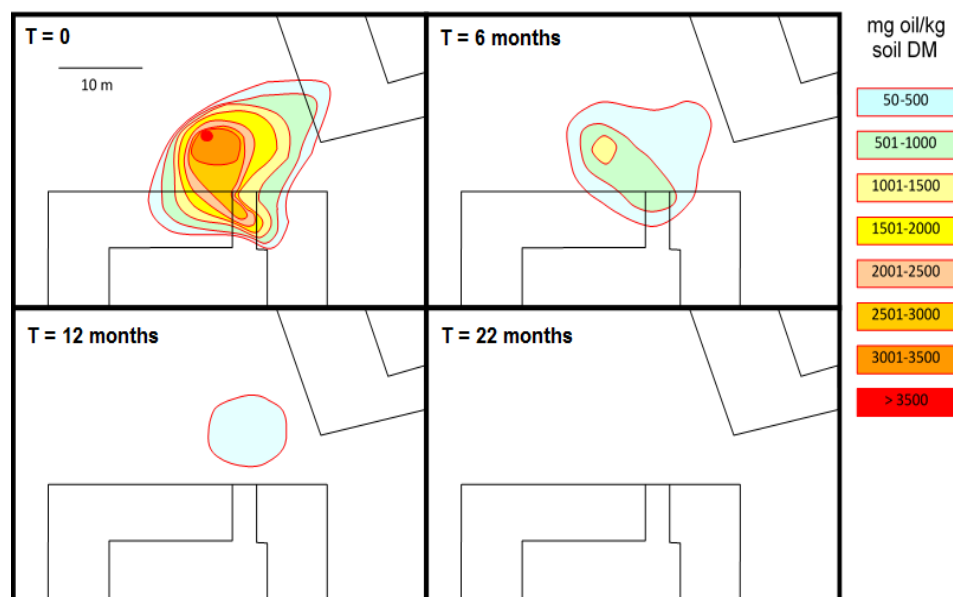
Figure 4: Spatial development of oil concentrations during EK remediation

Over a period of two years, concentrations decreased from an average of 2.172 to 23 mg TPH/kg.  $T_{1/2}$  for TPH was 99 days.

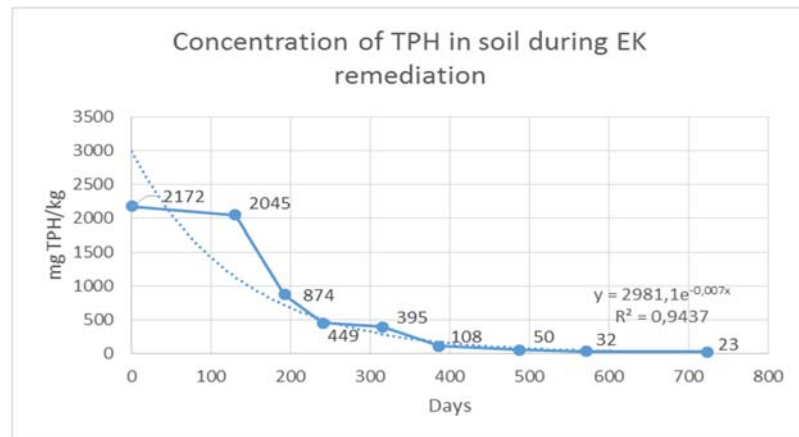
Figure 5: Development in oil concentrations during EK remediation

The results shows that the degradation follows first order kinetics as seen in Figure 5. As with remediations In-Situ degradations rates are higher the lighter the average molecular size T<sub>1/2</sub> ranging from ca. 100 days for C<sub>6</sub>-C<sub>10</sub> to 470 days for C<sub>25</sub>-C<sub>35</sub>.

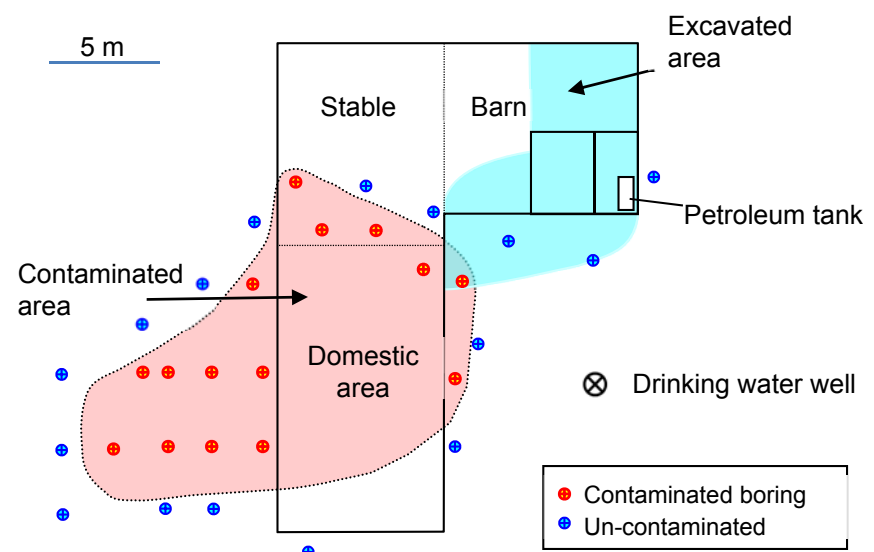
Figure 6: Situation plan over indoor petroleum vapour EK abatement

In order to abate indoor petroleum vapours installation of an EK system comprising two sets of electrodes took place a year later

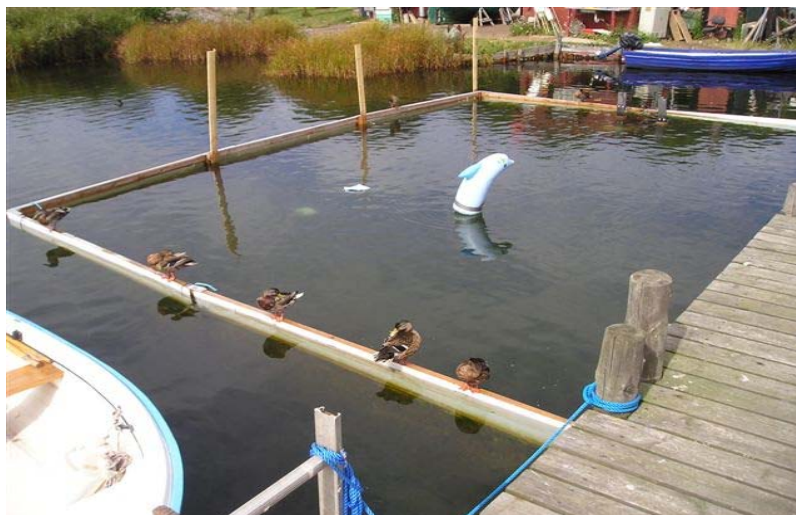
*Figure 8: EK pilot test area in Vordingborg Harbour during remediation.*

In order to prevent movement of sediment in and out of the 6 x 9 metres test area it was sheet piled with 10 mm HDPE plates in a wooden frame.

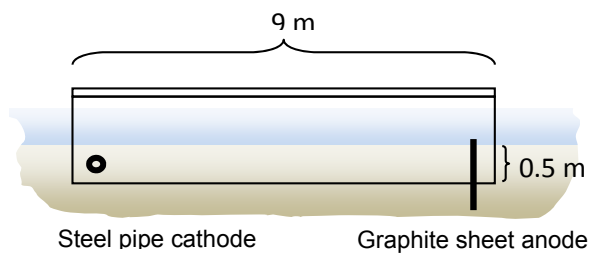
*Figure 9: Installation of electrodes in harbour sediment*

The electrodes were connected to a power supply placed on land.

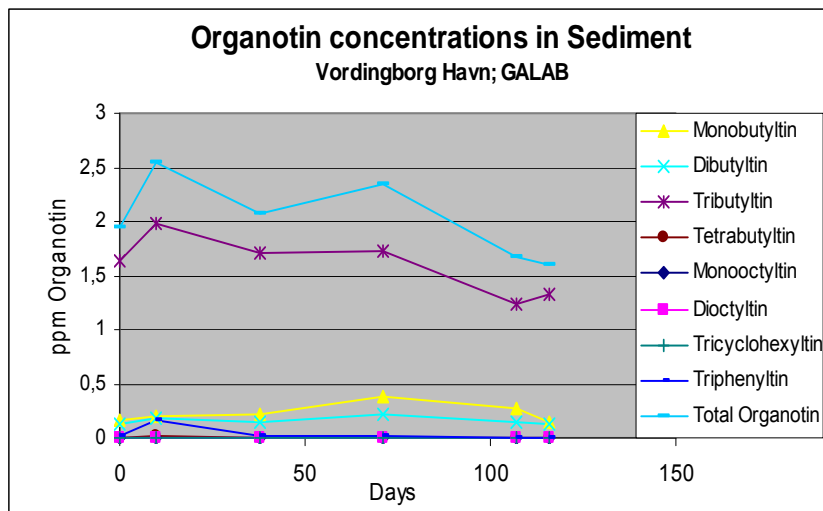
Figure 10: Organotin concentrations in sediment during EK remediation

Organotin concentrations decreased ca. 20 % during remediation corresponding to a  $T_{1/2}$  of 230 days.

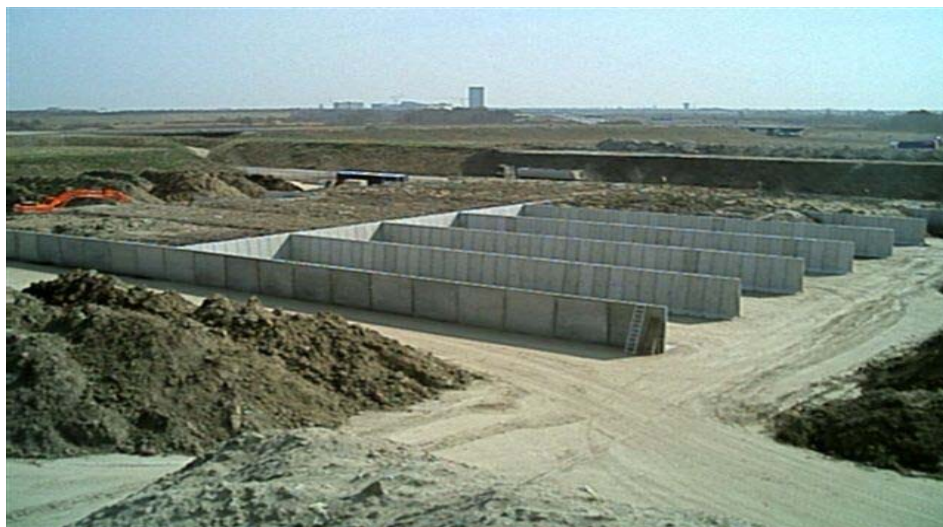
*Figure 11: EK remediation plant during first loading. Each bay measuring 10 x 30 x 3 metres has a capacity of 2,000 tons*

The results presented below represent all 65 parties of soil treated on the plant depicted on Figure 11 and Figure 12. The combined tonnage was ca.137,000 tons.

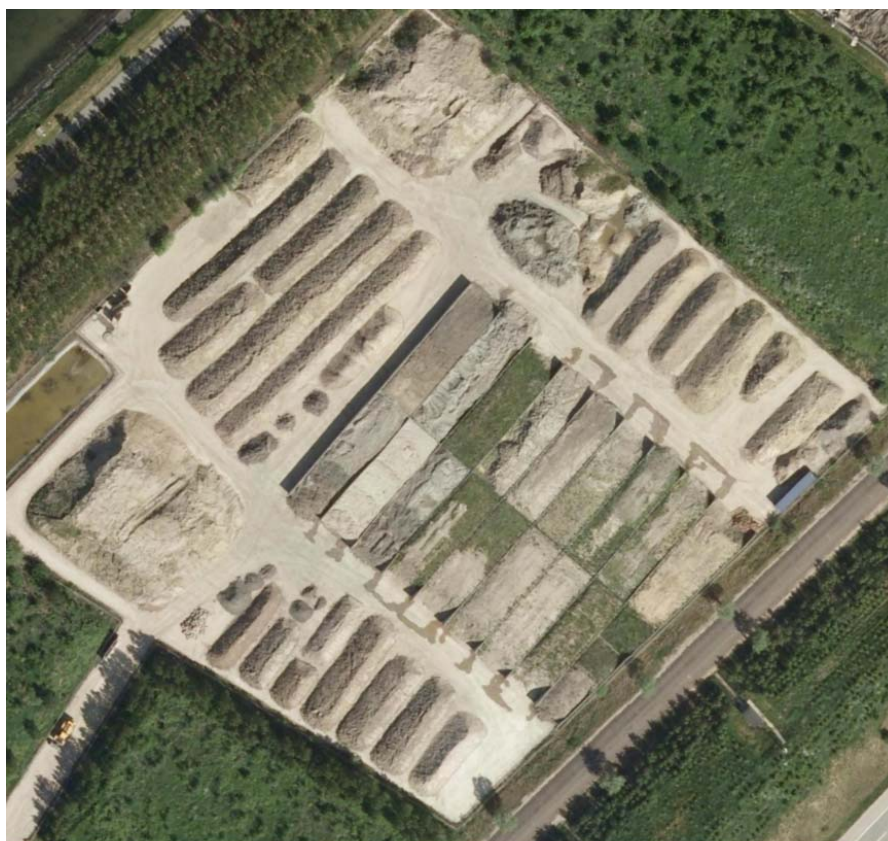
*Figure 12: The same EK plant as pictured above after extension to a total of 18 bays and 2 years operation. In addition, the soil heaps outside the bays are treated by EK.*
